Coal Operators' Conference

2015

Longwall Salvage Roof Fall Recovery Experience

LONGWALL SALVAGE ROOF FALL RECOVERY EXPERIENCE

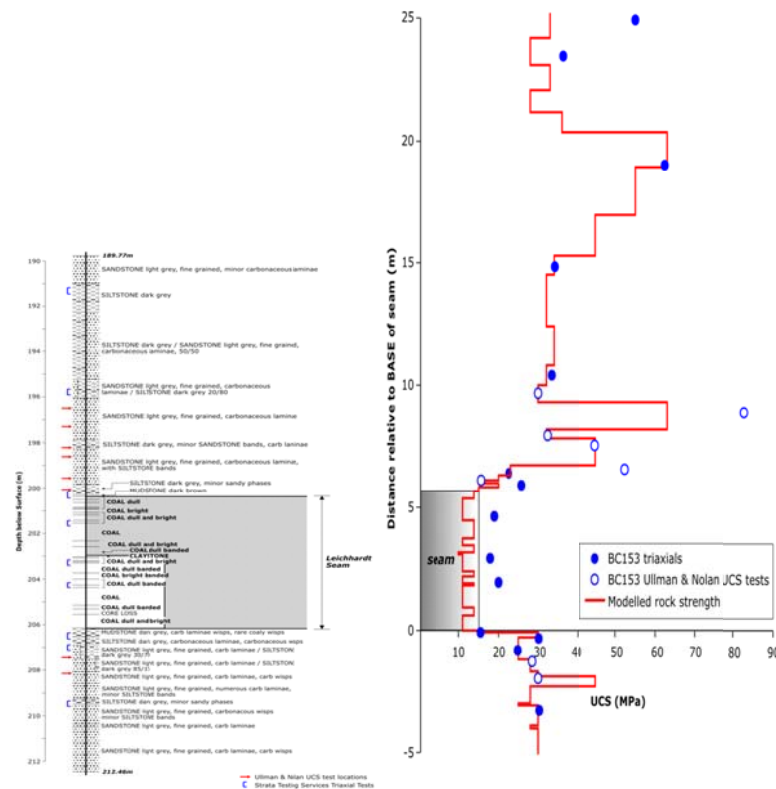
Depth of cover across Mine A ranges from 80 m, close to the pit bottom, to in excess of 400 m in the down dip northern extents of the lease. The experience base of LW salvages is within the 100 to 180 m range, with the fall of ground occurring at a depth of 165 m. The LW operates by extracting the lower 4.6 m of the seam, maintaining a 0.6 m - 1.0 m banded coal roof beam. The strata about the target seam is characterised by a moderate strength immediate siltstone/shale roof overlain by moderately bedded, stronger siltstone and sandstone units. Figure 1 shows the general stratigraphic column expected in the area of interest and the typical strata strength for the seam section.

Figure 1: Typical stratigraphic column and strata strength profile

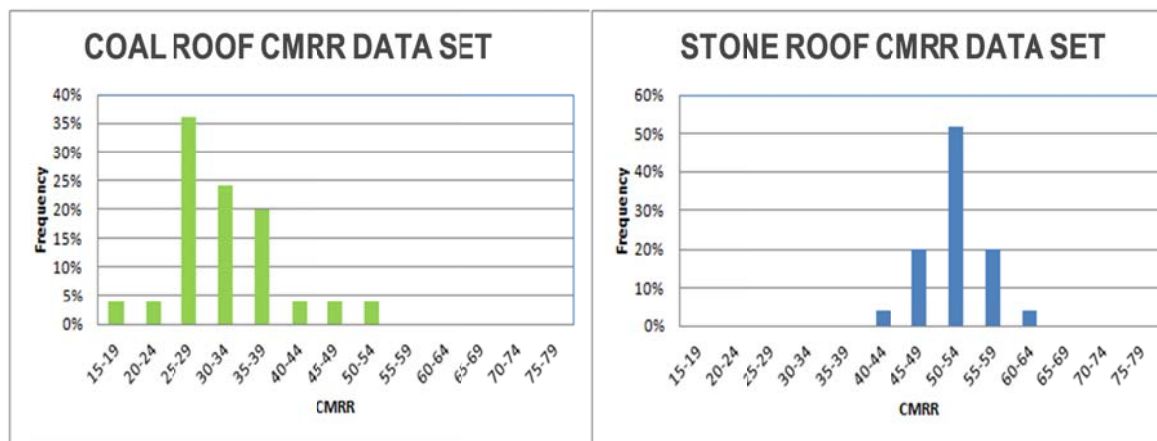
Analysis of the numerous boreholes across the lease indicates an average Coal Mine Roof Rating (CMRR) of 32 within the coal roof and 52 for the overlying stone roof. Figure 2 depicts the range of CMRR values in the data set for the coal roof and stone roof environments. Based on a study conducted

by Mark and Molinda (2003), the coal roof can be classified as “Moderate to Weak” and the stone roof is classified as “Strong”.

Figure 2: Summary of the CMRR data set

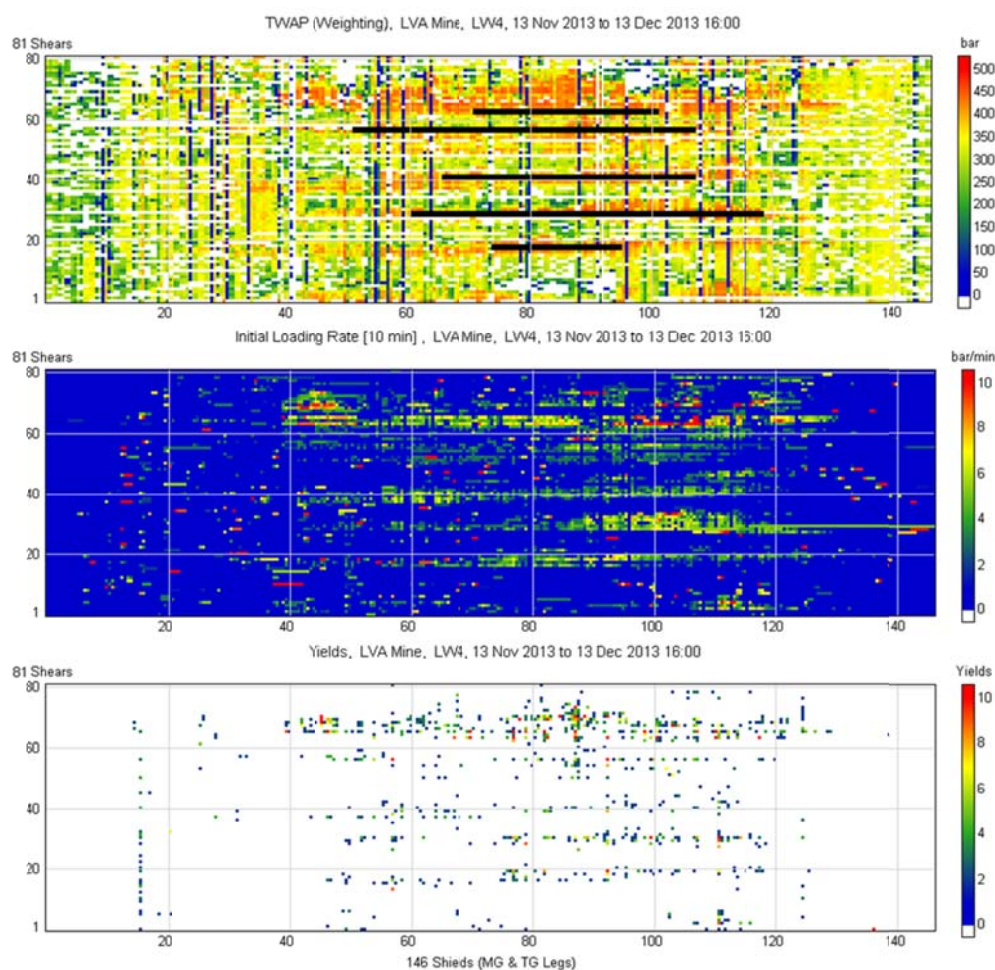
The roof strata are prone to periodic weighting cycles, typically at a 10 to 15 shear frequency. The common result of these frequent periodic weighting events, which are expressed as periods of rapid loading, and multiple yield events on shields in the affected zone, is an increased face spall and a roof gutter which runs parallel to the face – 600 mm wide and 500 mm high. Typically these events do not cause significant production issues. Figure 3 illustrates the typical time weighted average pressure TWAP & weighting events, loading rates and yield events leading up to the LW bolt up and salvage.

Figure 3: LVA data showing TWAP and weighting events, loading rates and yield events leading upto the LW bolt up and salvage
